➔ **Technical Report on El Limón Complex,
León and Chinandego Departments,
Nicaragua
Report for NI 43-101**

Calibre Mining Corp.

SLR Project No: 233.03320.R0000

March 30, 2021

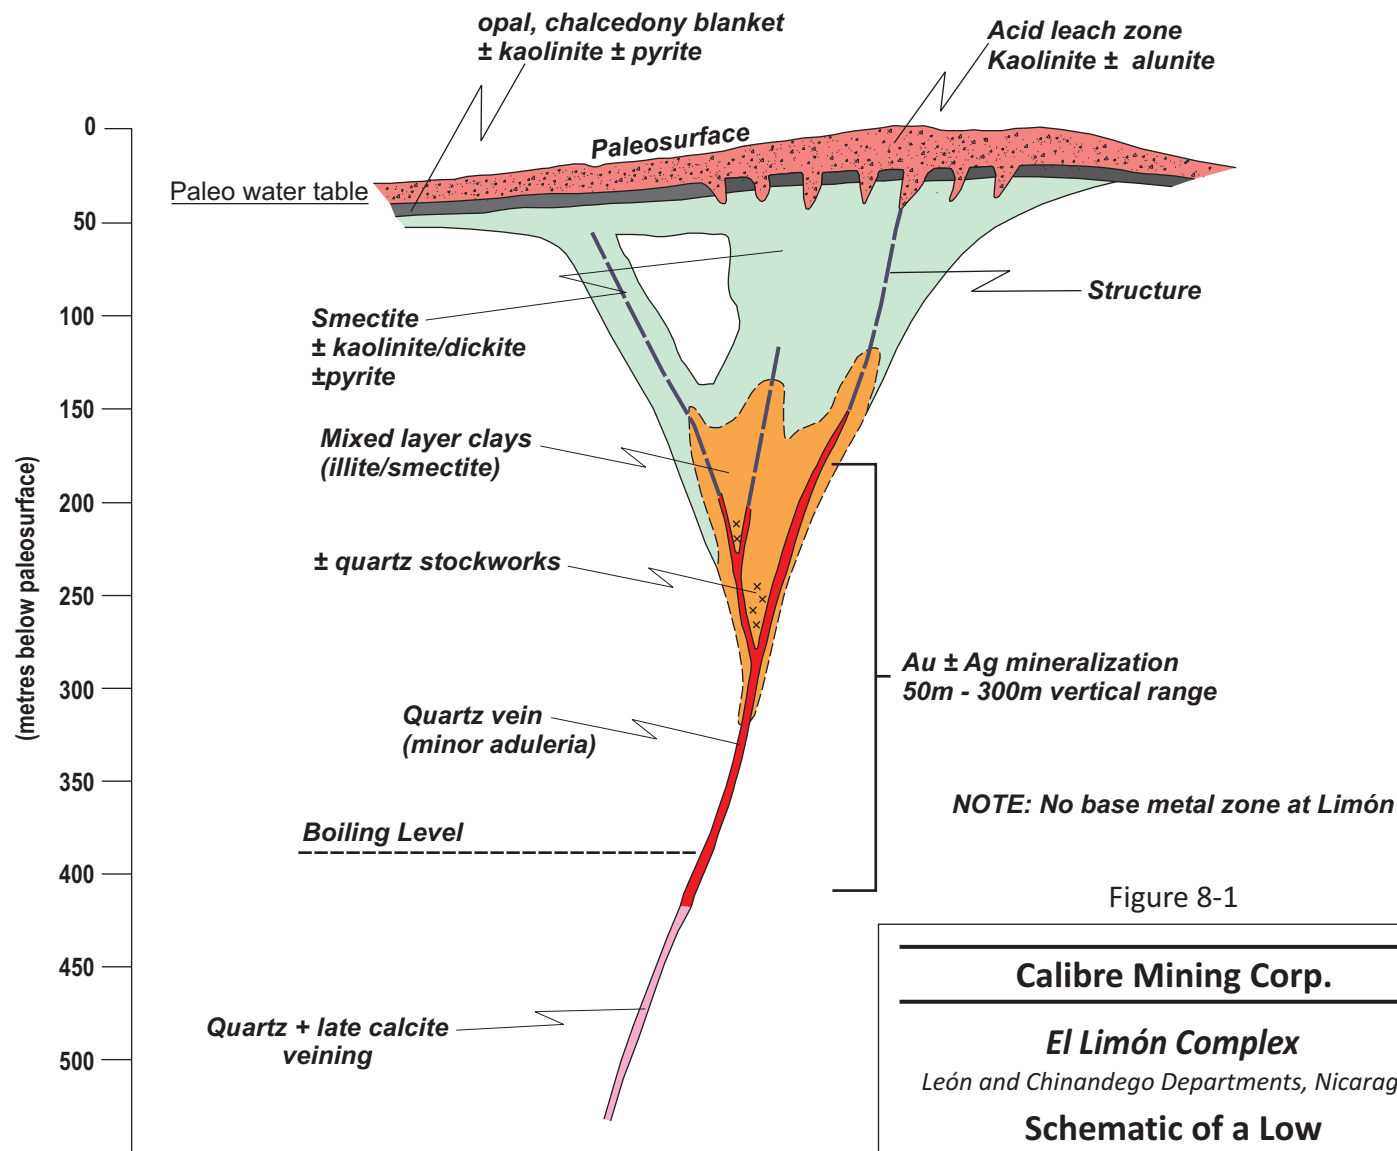
Calibre Mining Corp.
El Limón Complex
León and Chinandego Departments, Nicaragua
Schematic of a Low Sulphidation Deposit

Examples of low sulphidation gold deposits include Hishikari (Japan), Sleeper (Nevada), and Round Mountain (Nevada). Figure 8-1 is a schematic illustration of a low sulphidation deposit.

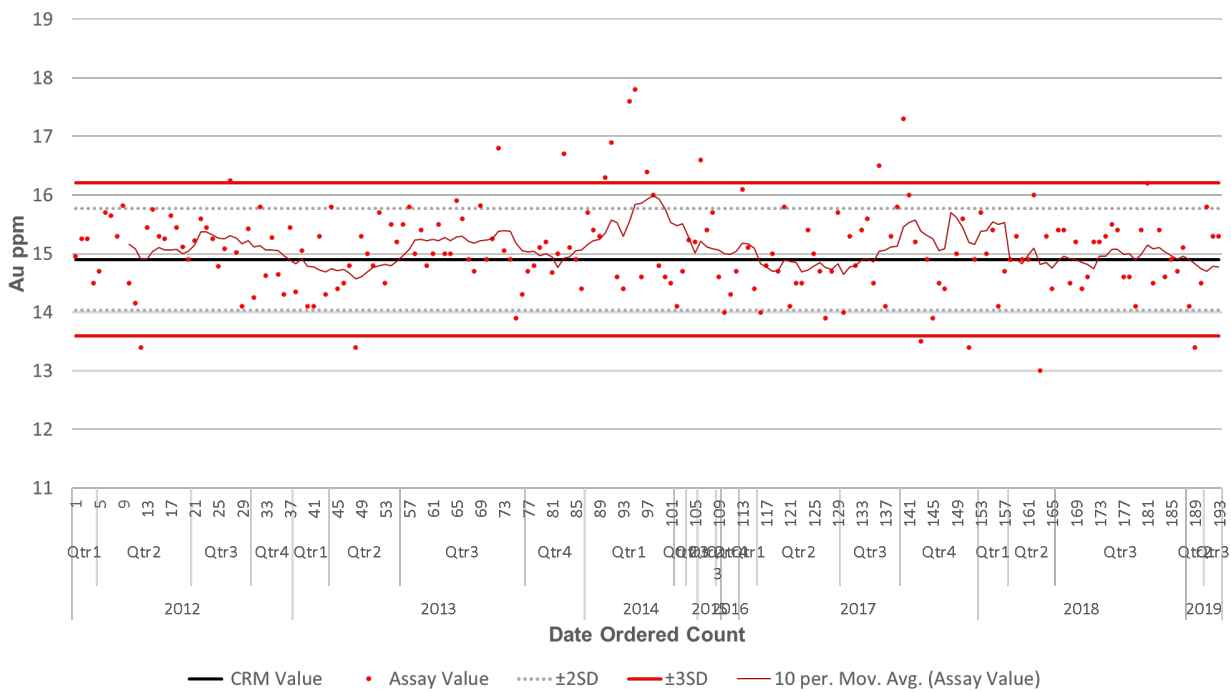
Figure 11-1: El Limón Control Chart of SRM GS14A (Gold)

Figure 11-1 charts 193 samples of standard GS14A used from 2012 through 2019. The mean value for the sample set is 15.076 ppm and had only 10 failures.

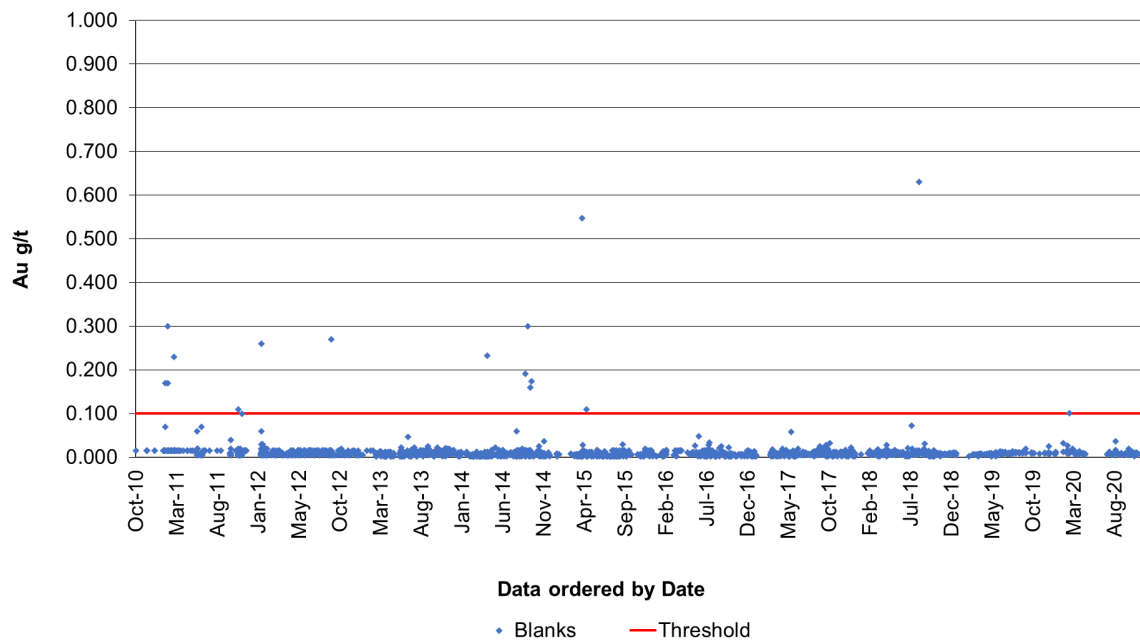
Figure 11-4: El Limón Chart of all Blanks (Gold)

The regular submission of blank material is used to assess contamination during sample preparation and to identify sample numbering errors. SLR analyzed and prepared charts depicting the performances of the blank sample submissions. The QA/QC protocol accepts results returning up to 10 times the detection limit as a pass. Detection limits for the gold blanks are set at 0.01 ppm Au

A total of 2,449 blank samples were sent for analysis. Figure 11-4 presents the performance of the blank material. Results indicate a negligible amount of sample contamination and sample numbering errors associated with samples from the Project.

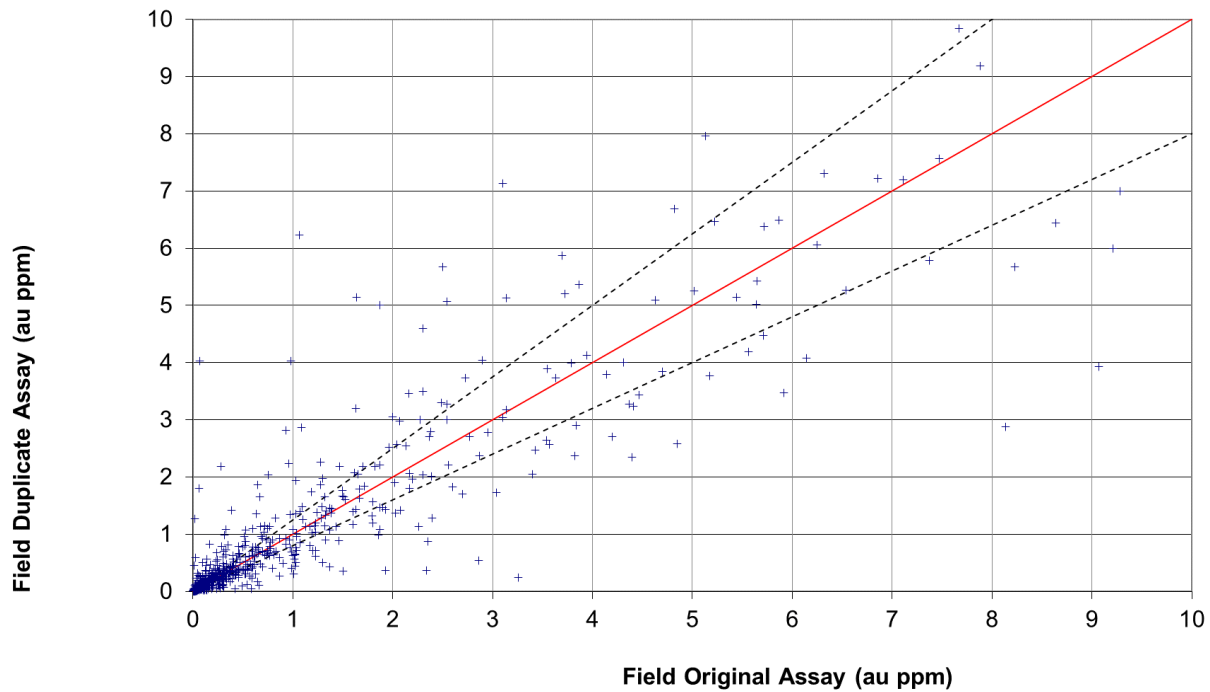
Figure 11-5: El Limón Field Duplicates (Gold)

SLR analyzed the duplicate data provided by Calibre using basic statistics, scatter, quantile-quantile, and percent relative difference plots. A total of 2,102 sample pairs were analyzed between field, coarse and pulp duplicates. Figure 11-5 through Figure 11-7 are selected duplicate results. Industry standards suggest that duplicate failures limits are as follows:

- Acceptable difference value for field duplicates is < 30%
- Acceptable difference value for coarse duplicate is < 20%
- Acceptable difference value for pulp is < 10 %

Overall, the results of the duplicate samples demonstrate good correlation between field, coarse reject, and pulp duplicates for both underground and surface samples.

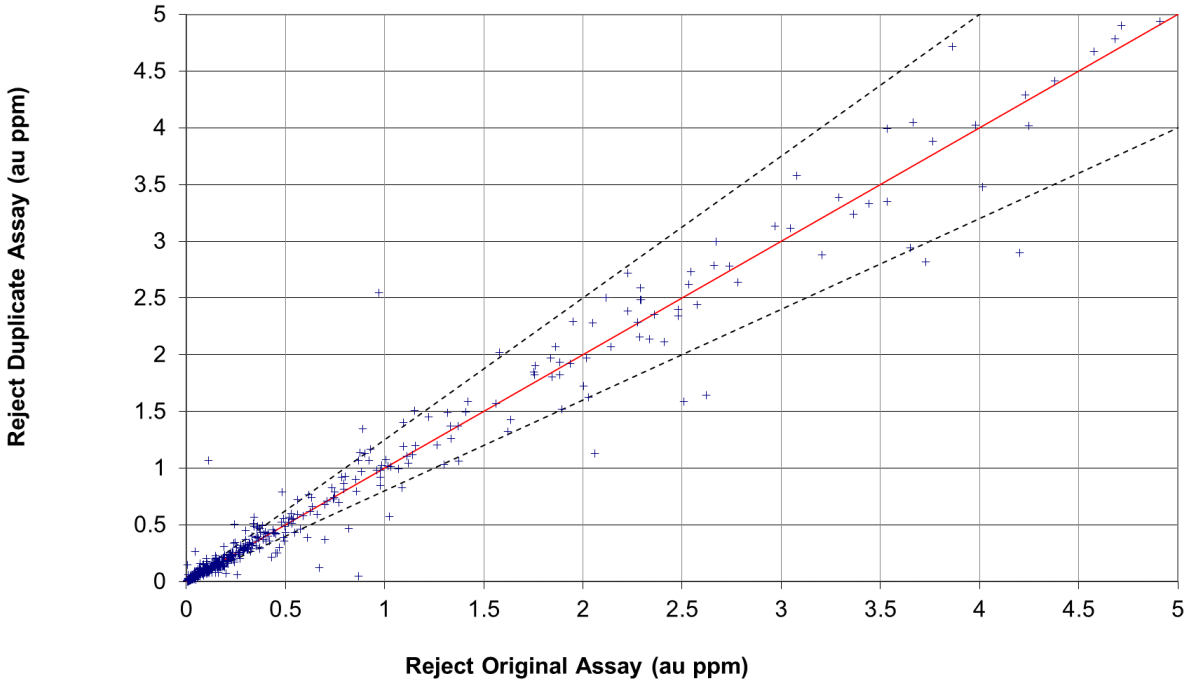
Figure 11-6: El Limón Coarse Reject Duplicates (Gold)

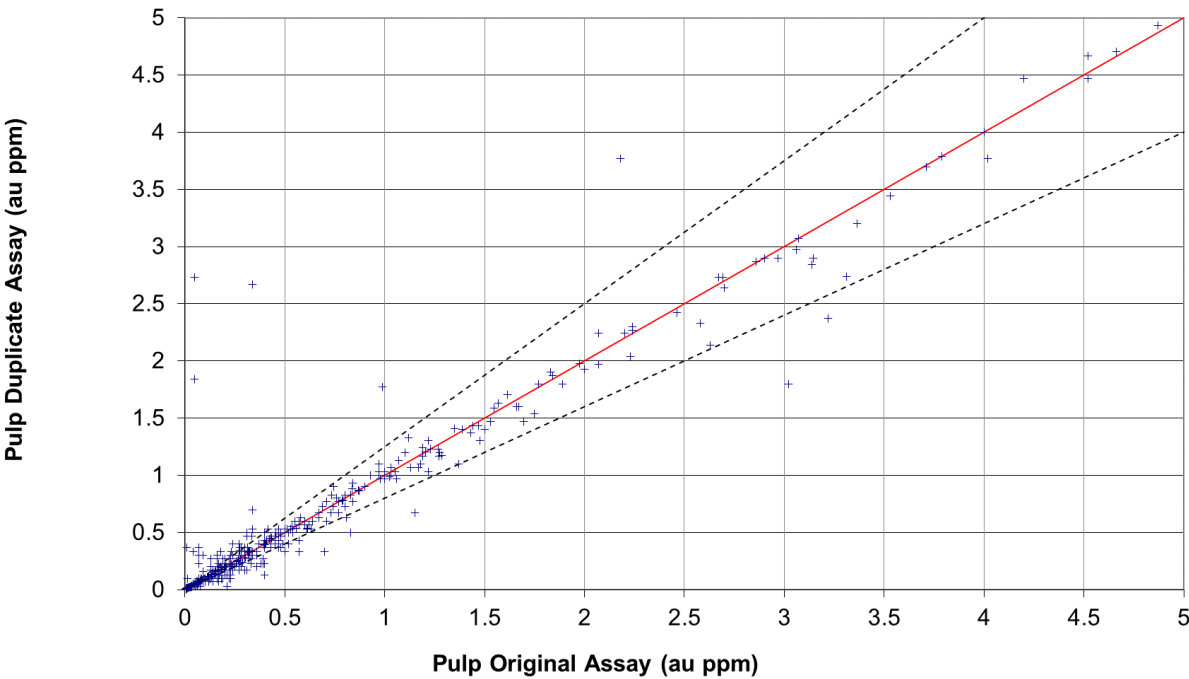
Figure 11-7: El Limón Pulp Duplicates (Gold)

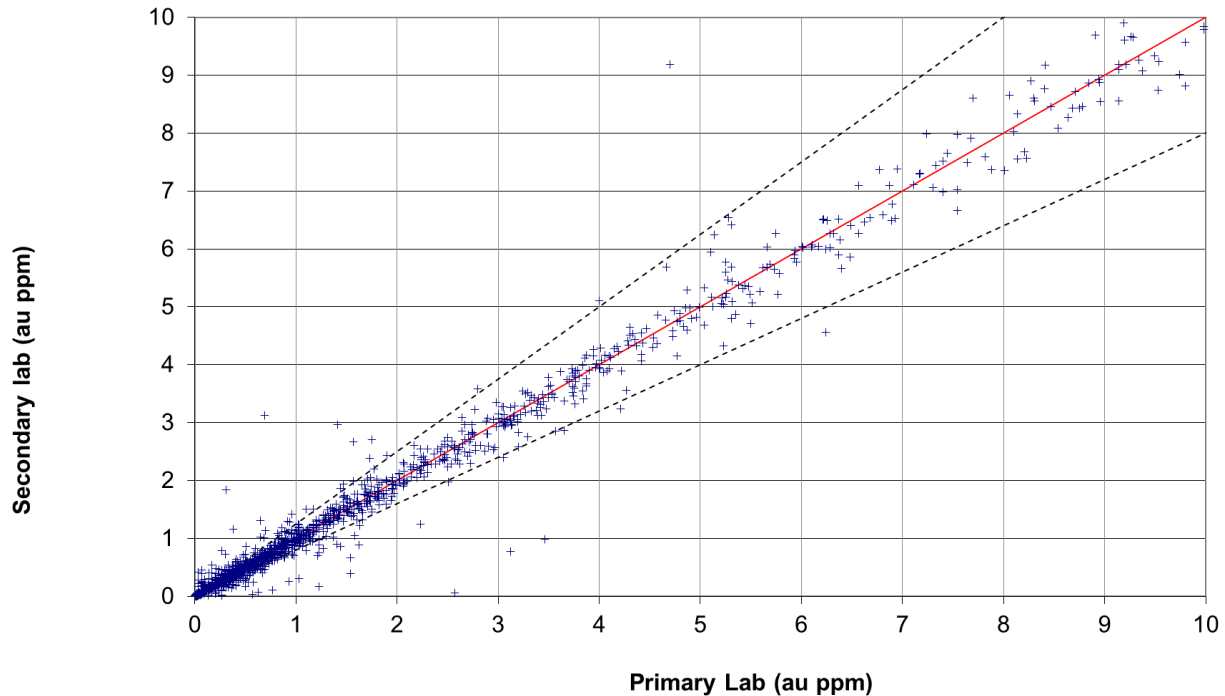
Figure 11-8: El Limón Secondary Lab and Primary Lab Duplicates (Gold)

Figure 11-8 plots 1,927 pulp sample pairs from the original laboratory against the external laboratory. The results indicate minimal variation in assay values and an overall 1% bias towards the original assay laboratory.

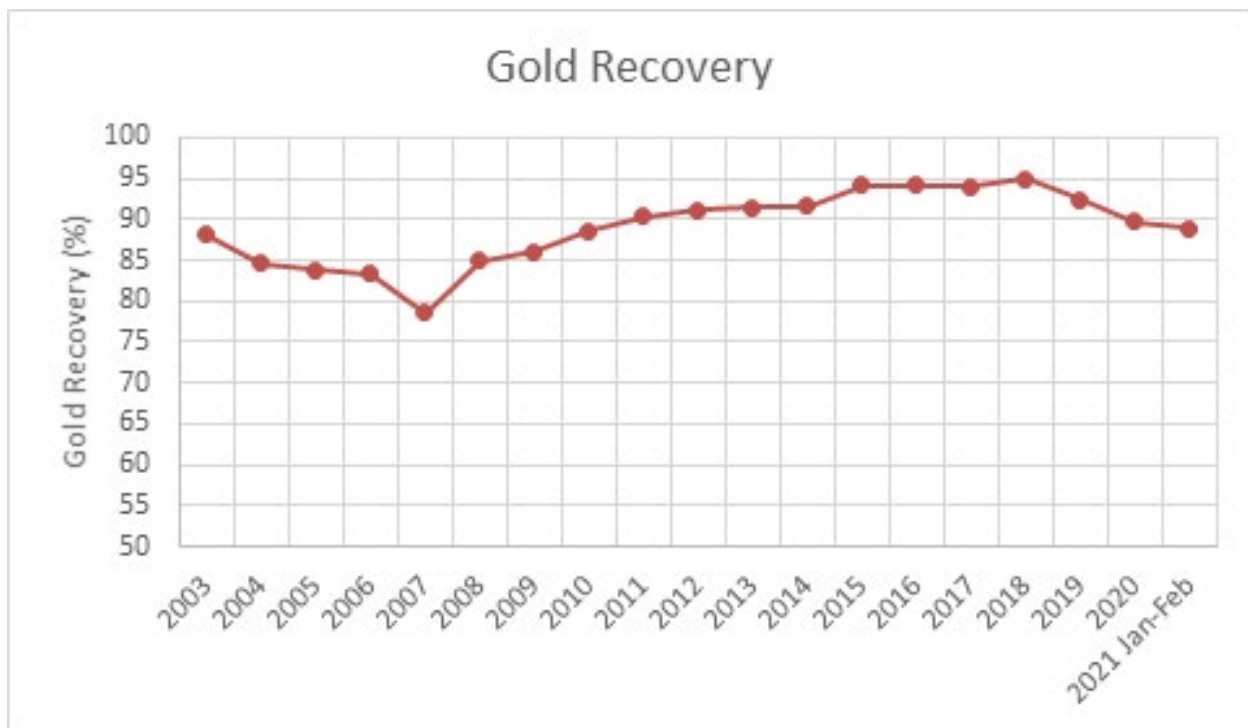
Figure 13-1: El Limón Gold Recovery

Gold recovery during 2019 and 2020 was 92.5% and 89.8% respectively, with recovery in the first two months of 2021 at 88.9% (Figure 13-1). Recovery in this range is expected to continue considering the deposits being processed. Metallurgical testing in 2018 and 2021 indicate overall average gold recoveries of 88.2% and 90.9%, respectively, with variations depending on the material being processed. SLR notes that silver data is not reported in El Limón monthly reports. Silver extraction during 2021 test work ranged from 53% to 91.9%, with an average of approximately 80%.

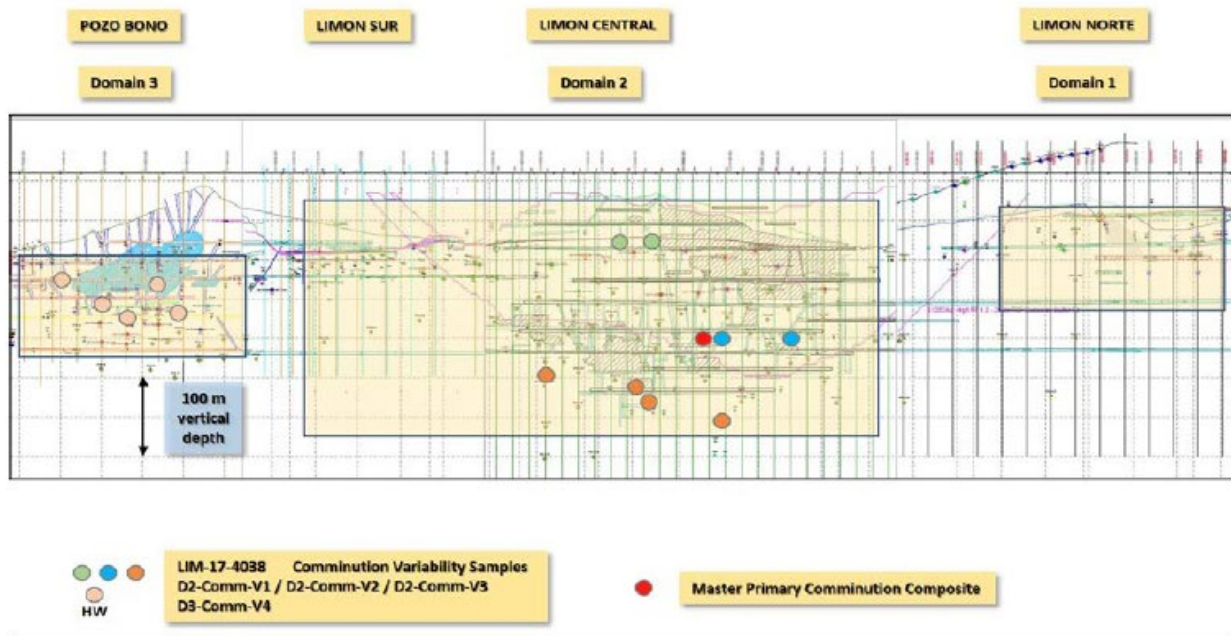
Figure 13-6: Limón Vein Metallurgical Spatial Domains and Domain Sample Locations

A separate drilling program was conducted for the collection of samples for comminution testing. The composite sample descriptions and sample depths are presented in Table 13-9 and the locations of the comminution samples are shown in Figure 13-6.

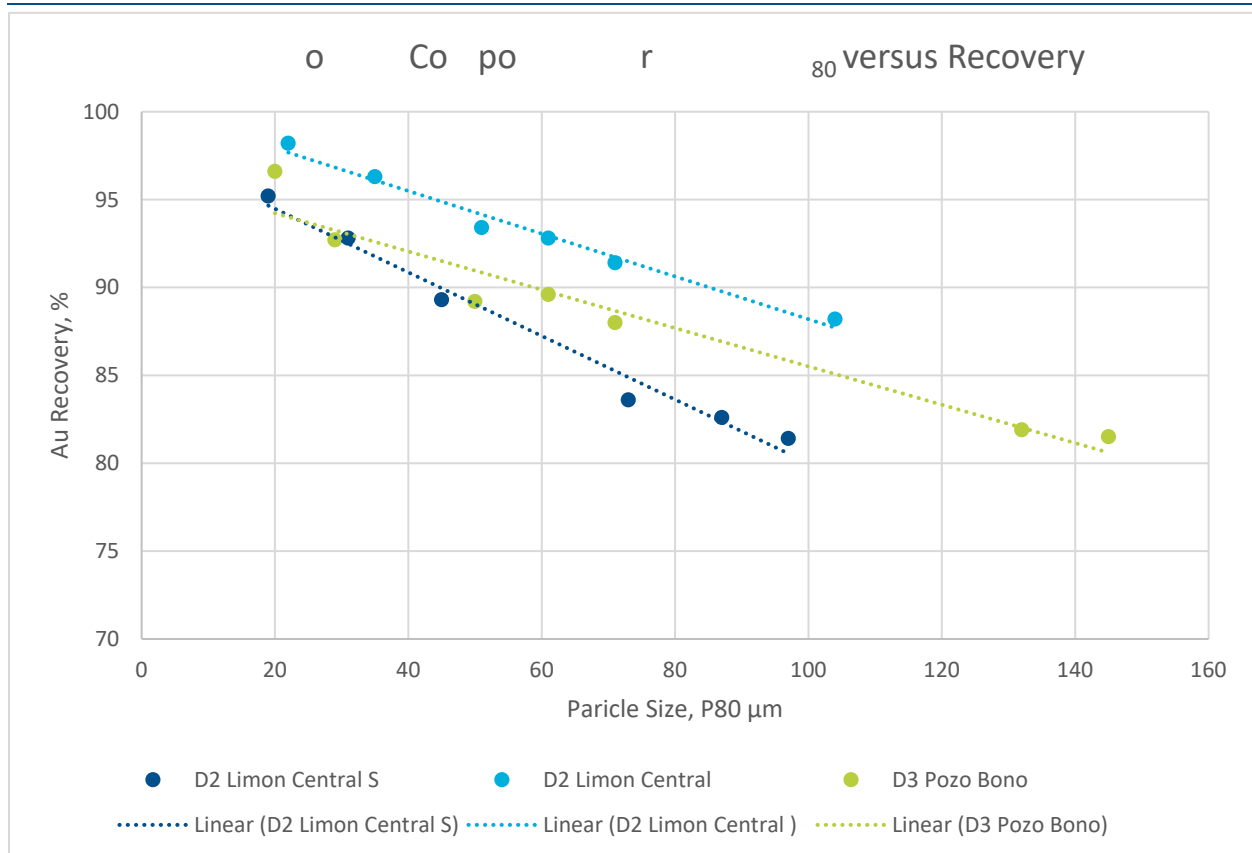
Figure 13-7: Limón Domain Composites, P₈₀ Particle Size versus Recovery

Whole ore bottle roll cyanide leach tests were performed on the D1, D2, and D3 Domain composites and variability composites to determine the effects of grind size, cyanide concentration, and leach retention time on gold and silver extraction and reagent consumption. The results of the Domain composite tests are presented in Table 13-11 and Figure 13-7. El Limón mill standard leach conditions are:

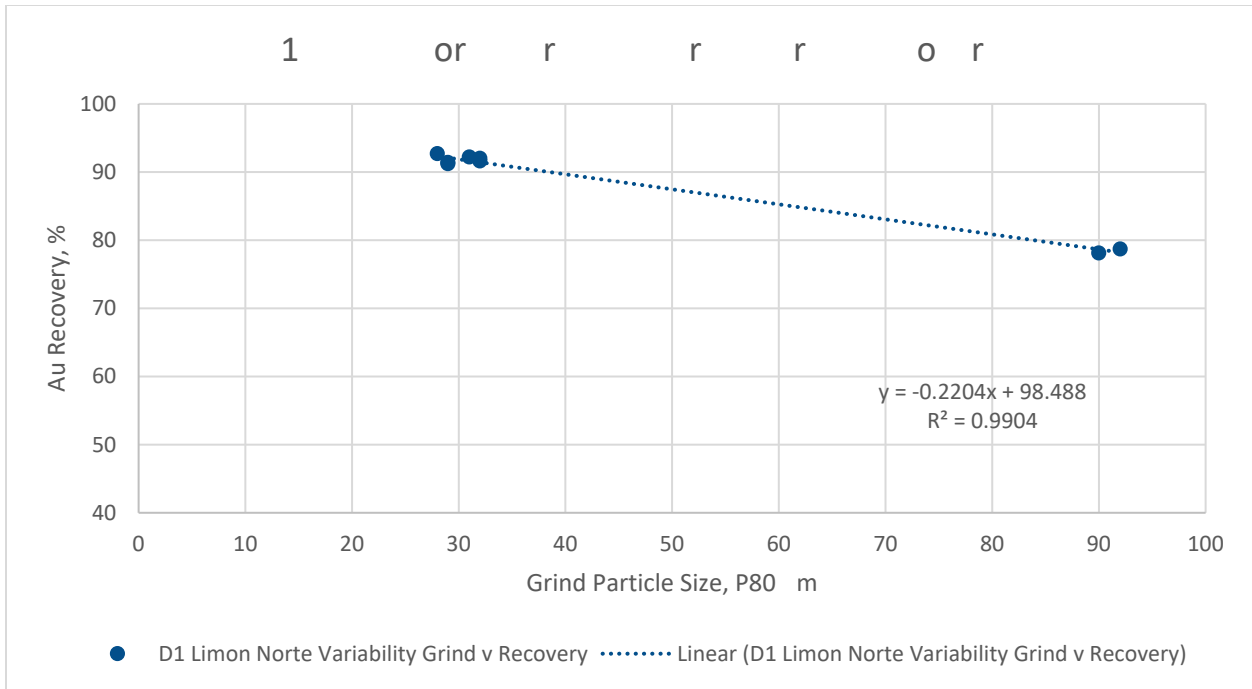
Figure 13-8: D1 Limón Norte Optimized Variability Grind versus Recovery

74 μm , respectively. The actual grind sizes tested ranged from P_{80} 27 μm to P_{80} 120 μm . The variability samples were collected from each of the three Domain areas, D1 Limón Norte, D2 Limón Central, and D3 Pozo Bono. The results of the tests were used to generate grind particle size versus recovery curves. The results of the tests are presented in Table 13-12, and Figure 13-8 to Figure 13-10.

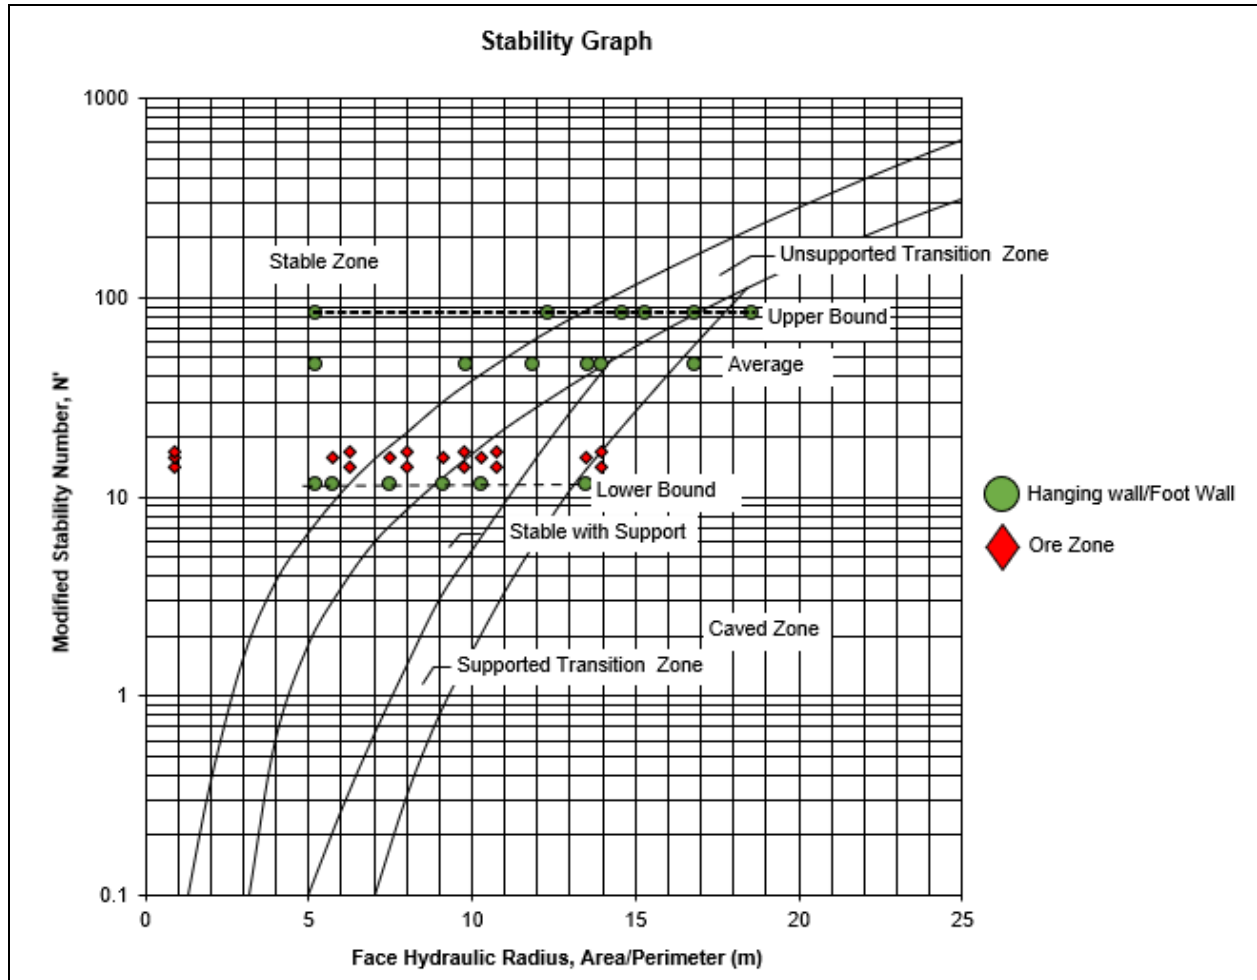
Figure 16-16: Matthews Stability Graph

SLR evaluated the stope dimensions using Matthews Stability Graph method (Figure 16-16). Based on this assessment the ground conditions at Panteón are deemed suitable for the sublevel stoping type mining method and the proposed stope geometry with a height of 22 m and length of 20 m is achievable. A first pass empirical assessment has been carried out to assess pillar size using the Pillar Stability Graph developed by Lunder and Pakalnis (1997) and further modified by Martin and Maybee (2000). Assuming a pillar stress of 27 MPa and a global rock mass strength of 90 MPa, the pillar stress to rock strength ratio will be 0.3. Based on these assumptions a pillar width/height ratio required would be 1 for a FOS of 1.4.

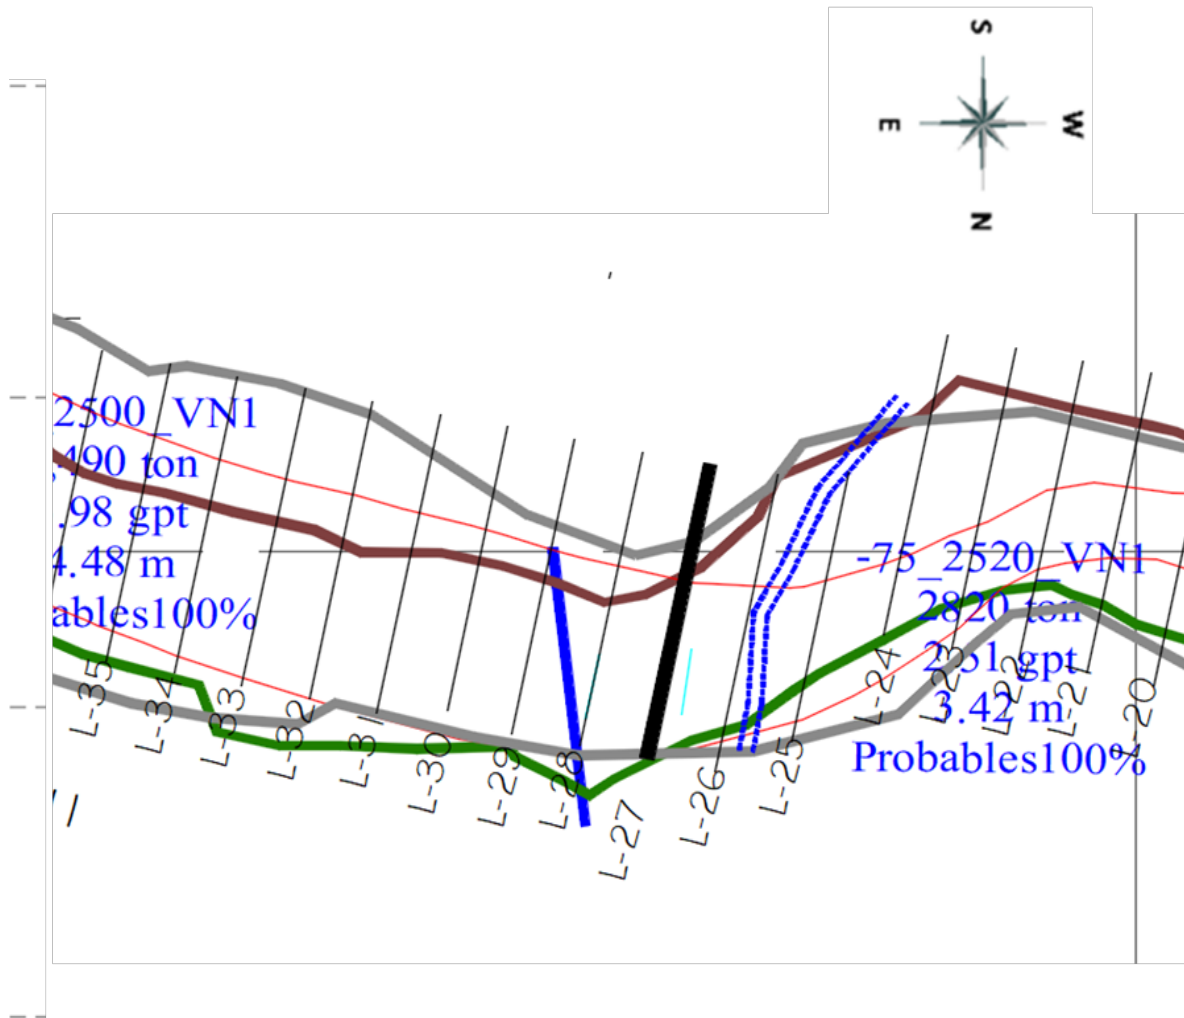
Figure 16-21: Typical Layout for Longhole Drilling Veta Nueva – Plan View
