September 2023 – Limon Complex – Atravesada Underground Deposit

▲ Limon Mine Complex – Atravesada VTEM Resistivity Plan View

▲ Limon Mine Complex – Atravesada – Veta Nueva Longitudinal Section

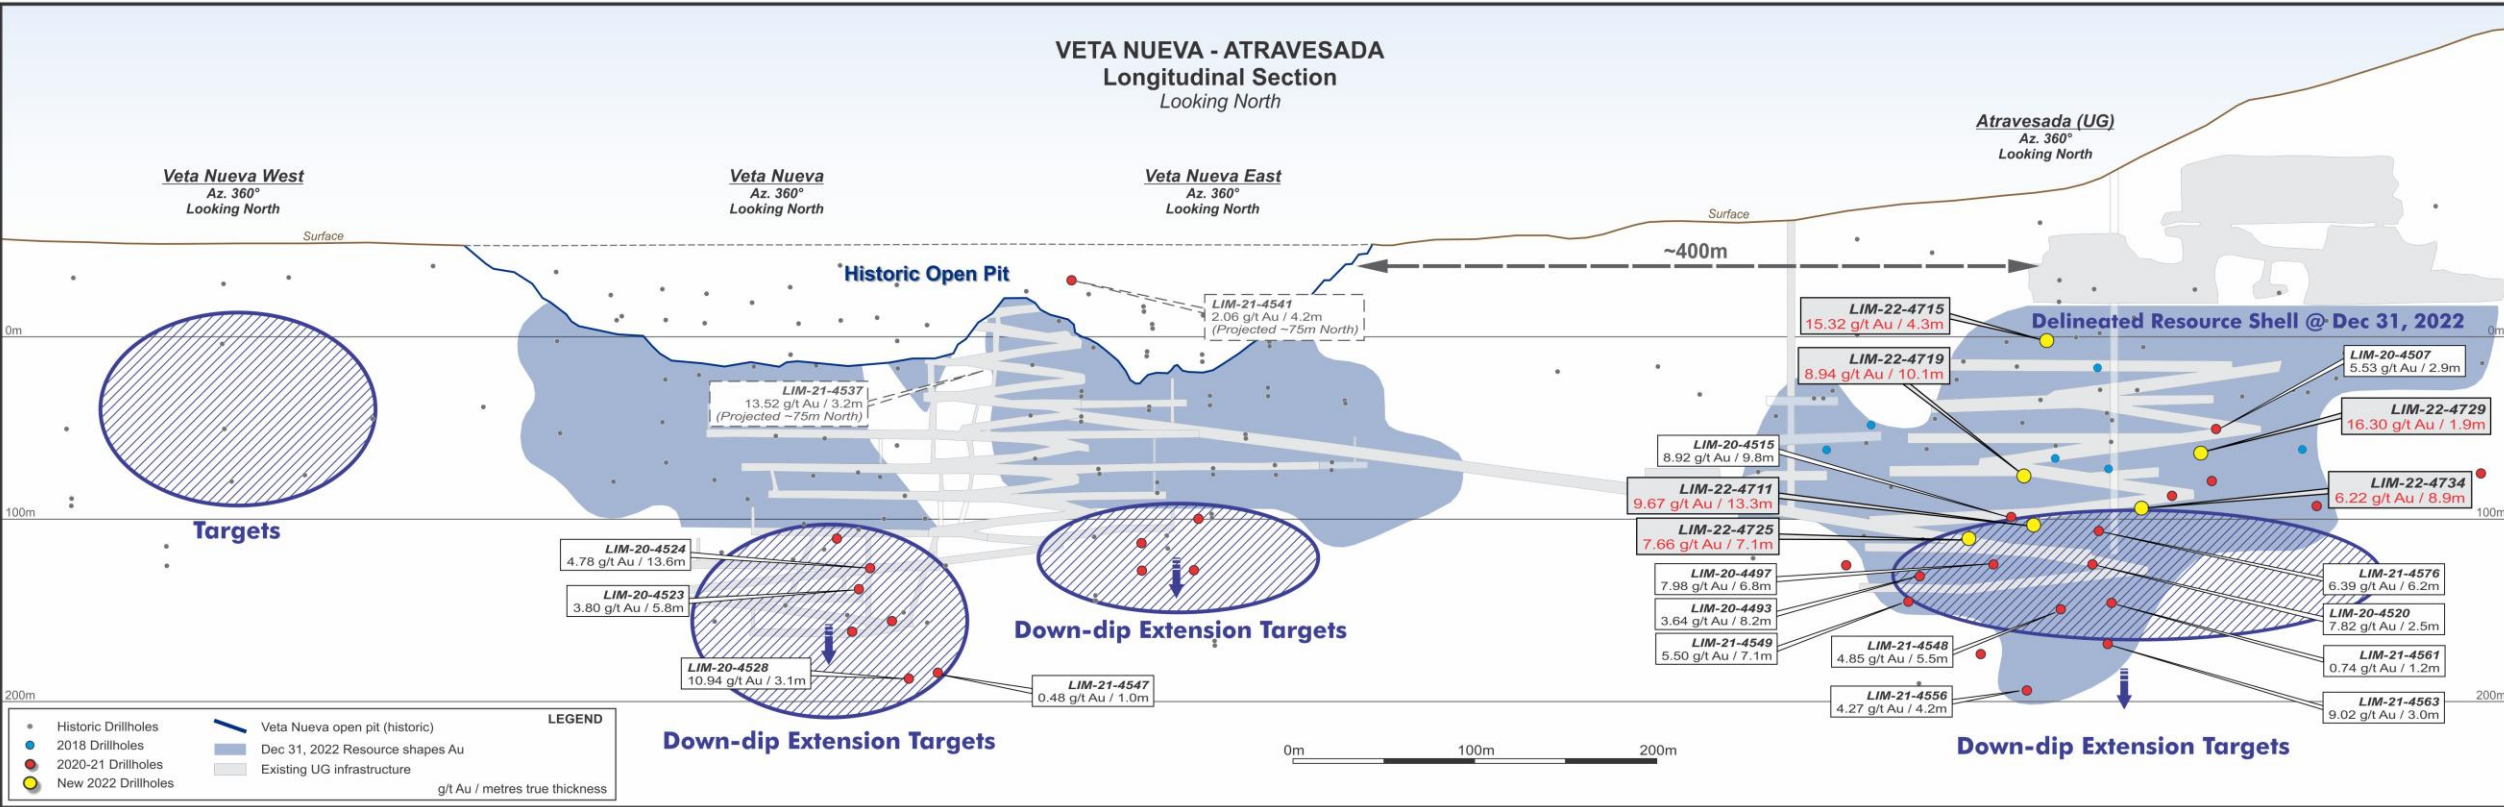
VETA NUEVA - ATRAVESADA Longitudinal Section Looking North

Veta Nueva West
Az. 360°
Looking North

Veta Nueva
Az. 360°
Looking North

Veta Nueva East
Az. 360°
Looking North

Atravesada (UG)
Az. 360°
Looking North

g/t Au / metres true thickness
